UNITED STATES ENVIRONMENTAL PROTECTION AGENCY

SUBJECT: Former CertainTeed Transite Plant, St. Louis, Missouri,
Site Asbestos Evaluation, 7/19/93 (SBR23)

CERTAINTEED
ST. LOUIS, MO
NORTHEAST BUILDING
7/19/93
SBR23

CERTAINTEED, ST. LOUIS, MO
 SOUTHWEST BUILDING
 7/19/93
 SBR23

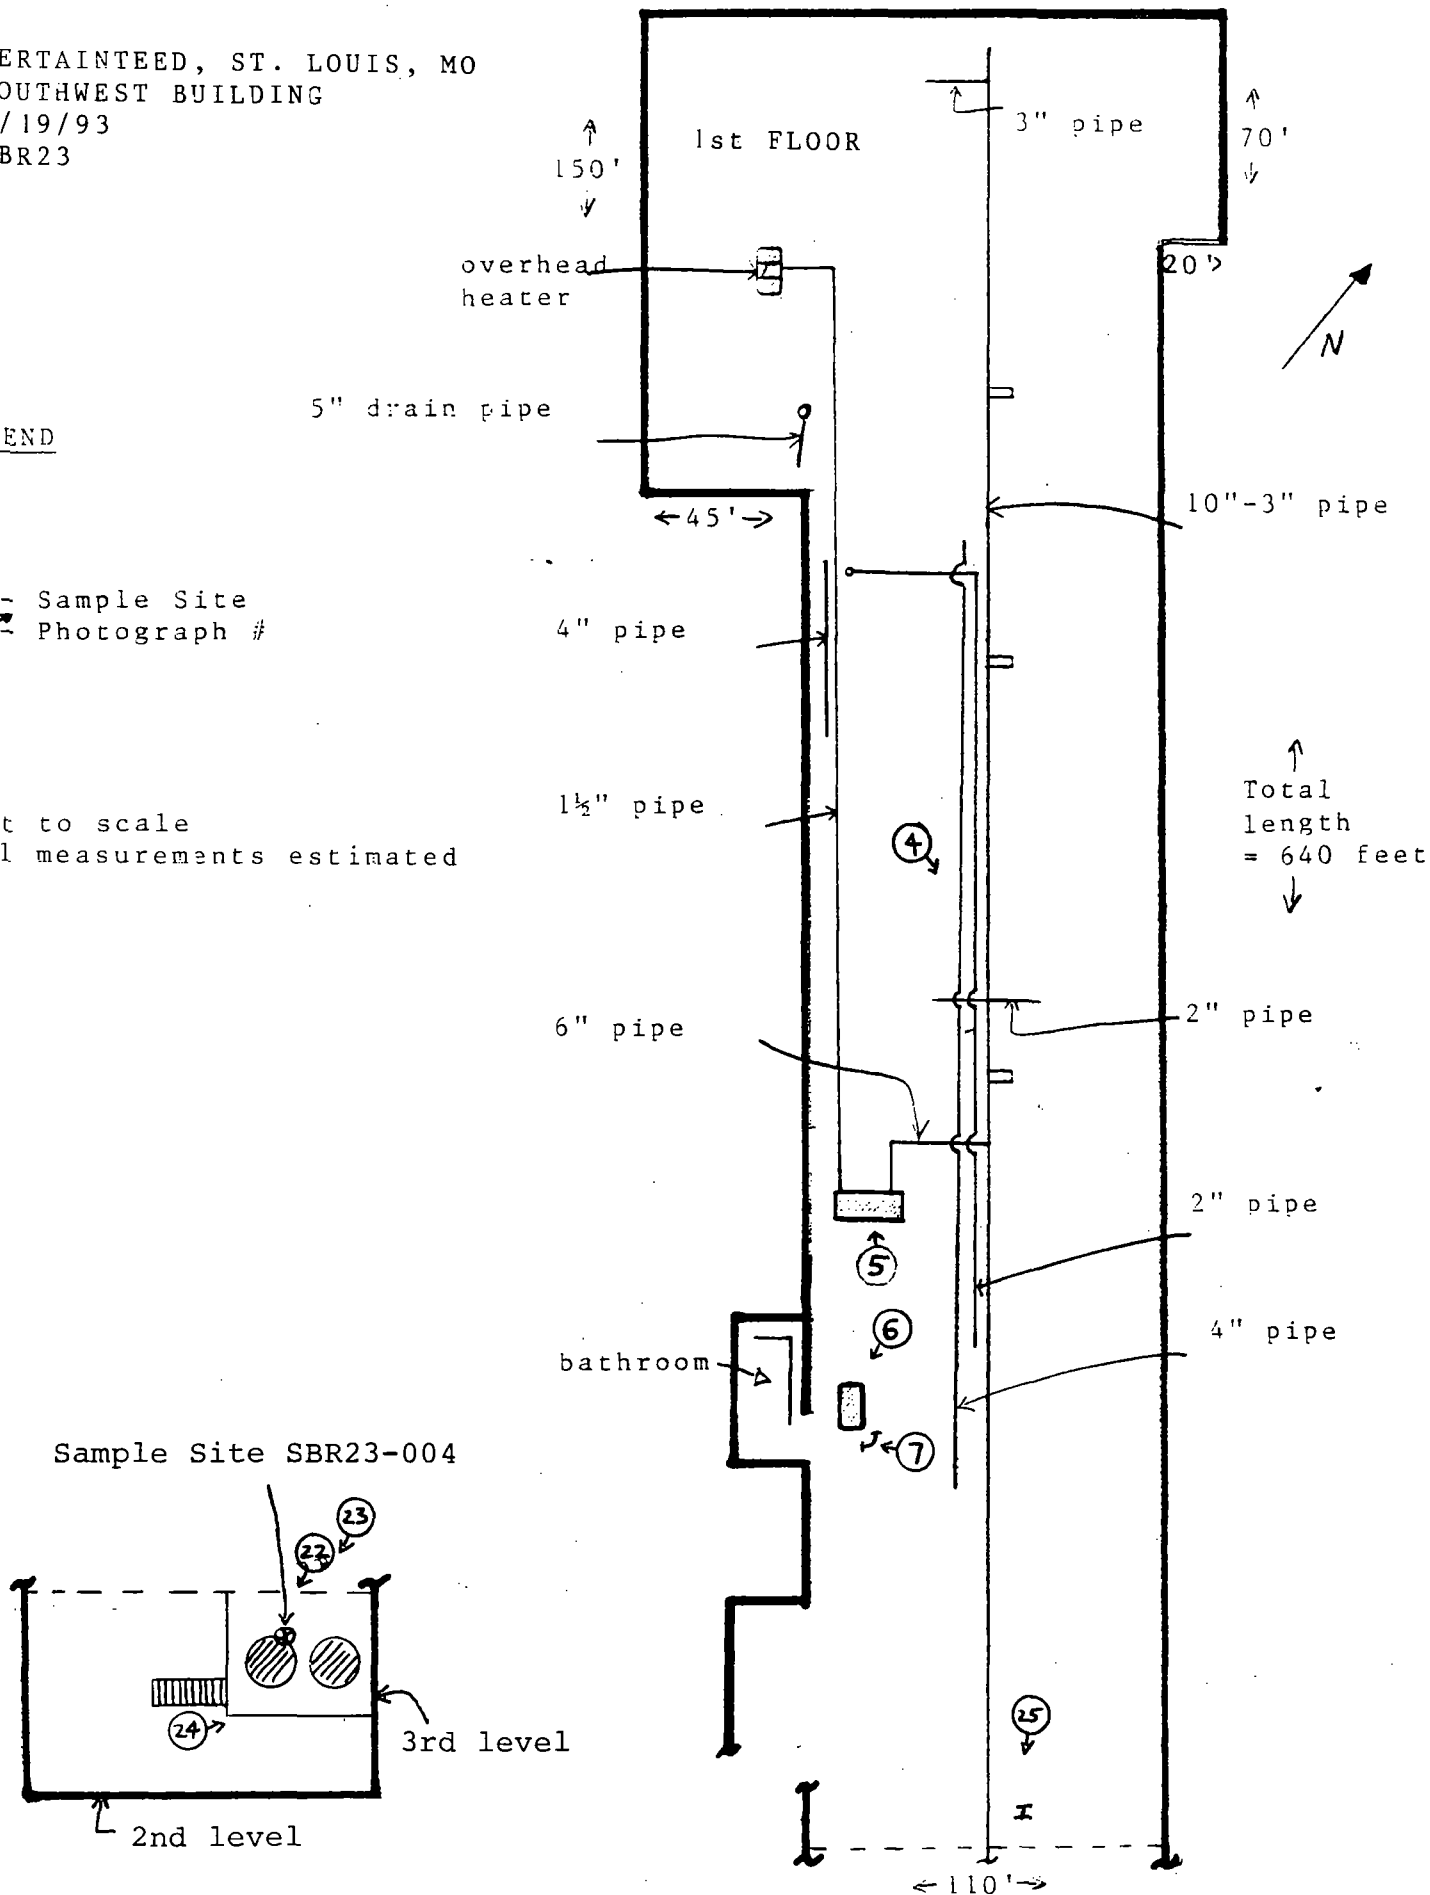
The asbestos in the tank on the second level was still present.

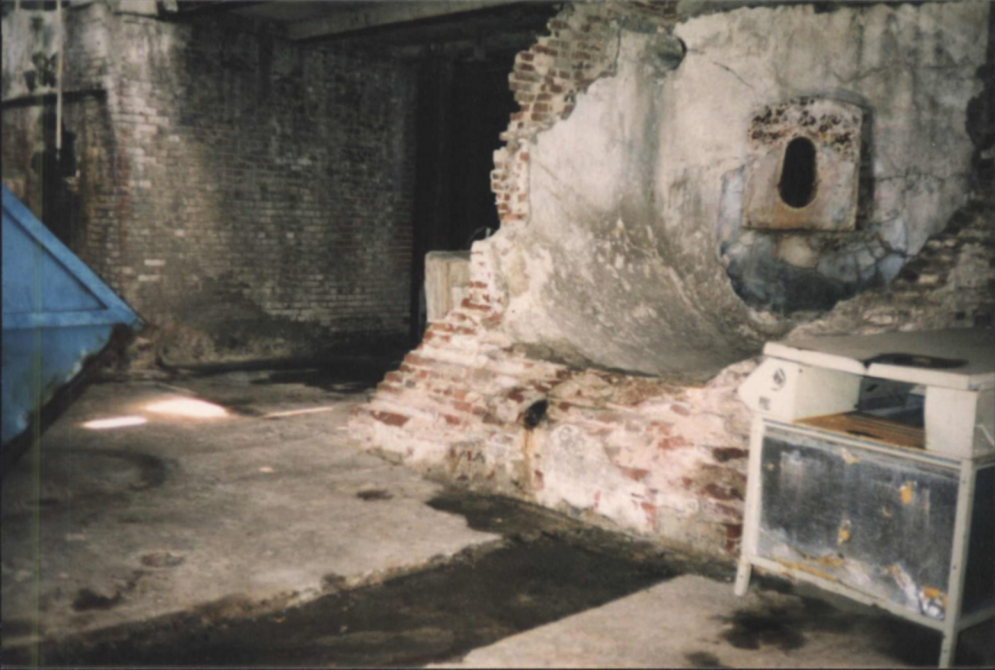
Photo #8

It appeared that the majority of the bulk ACM located in the southwest building has been cleaned-up. There is still general dust and some debris that could contain asbestos, but the areas of gross contamination appear to have been cleaned adequately (Photos #8 and #9). The insulated pipes in the northeast building, area C have been abated (Photo #13).
